Appendix B
Detailed In Situ Grouting Case Studies

Detailed In Situ Grouting Case Studies

The following case studies summarize the work accomplished to date using in situ grouting (ISG) to stabilize or contain radioactive waste sites at U.S. Department of Energy (DOE) facilities.

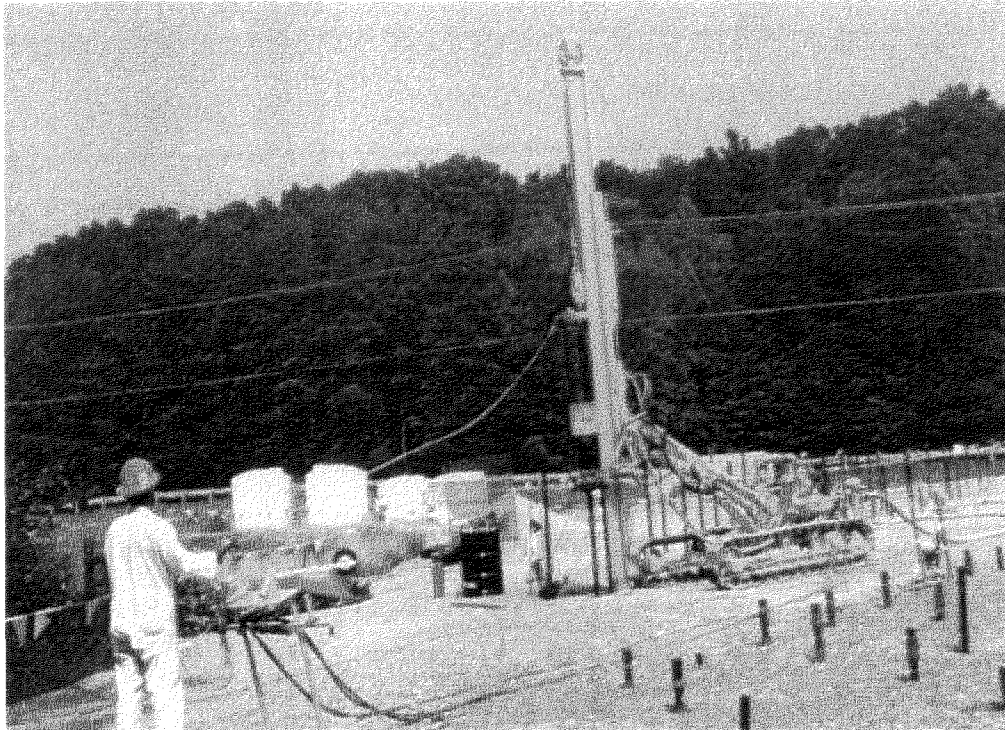
Figure B-1. Grouting Trench 1 at the Oak Ridge National Laboratory (ORNL 1997).

The technique selected for use at the BNL WAG 4 employed three types of grout: (1) regular cement, (2) ultra fine cement, and (3) acrylamide solution grout. As shown in Figure B-1, grout was injected through sleeve pipes (tube-a-manchettes) driven into areas to be grouted.

Sleeve pipes were constructed of steel with a minimum 2 in. inside diameter. Grout ports in the pipes were arranged in sets of at least four openings, with a maximum spacing of 20 in. and a diameter of 0.5 in. Grout ports were protected by rubber sleeves that acted as one-way valves allowing grout to flow to the outside while preventing material from flowing in from outside. Sleeve pipes were flushed with water after each application of grout to prevent grout from setting up in the pipe and preventing subsequent application of other grouts.

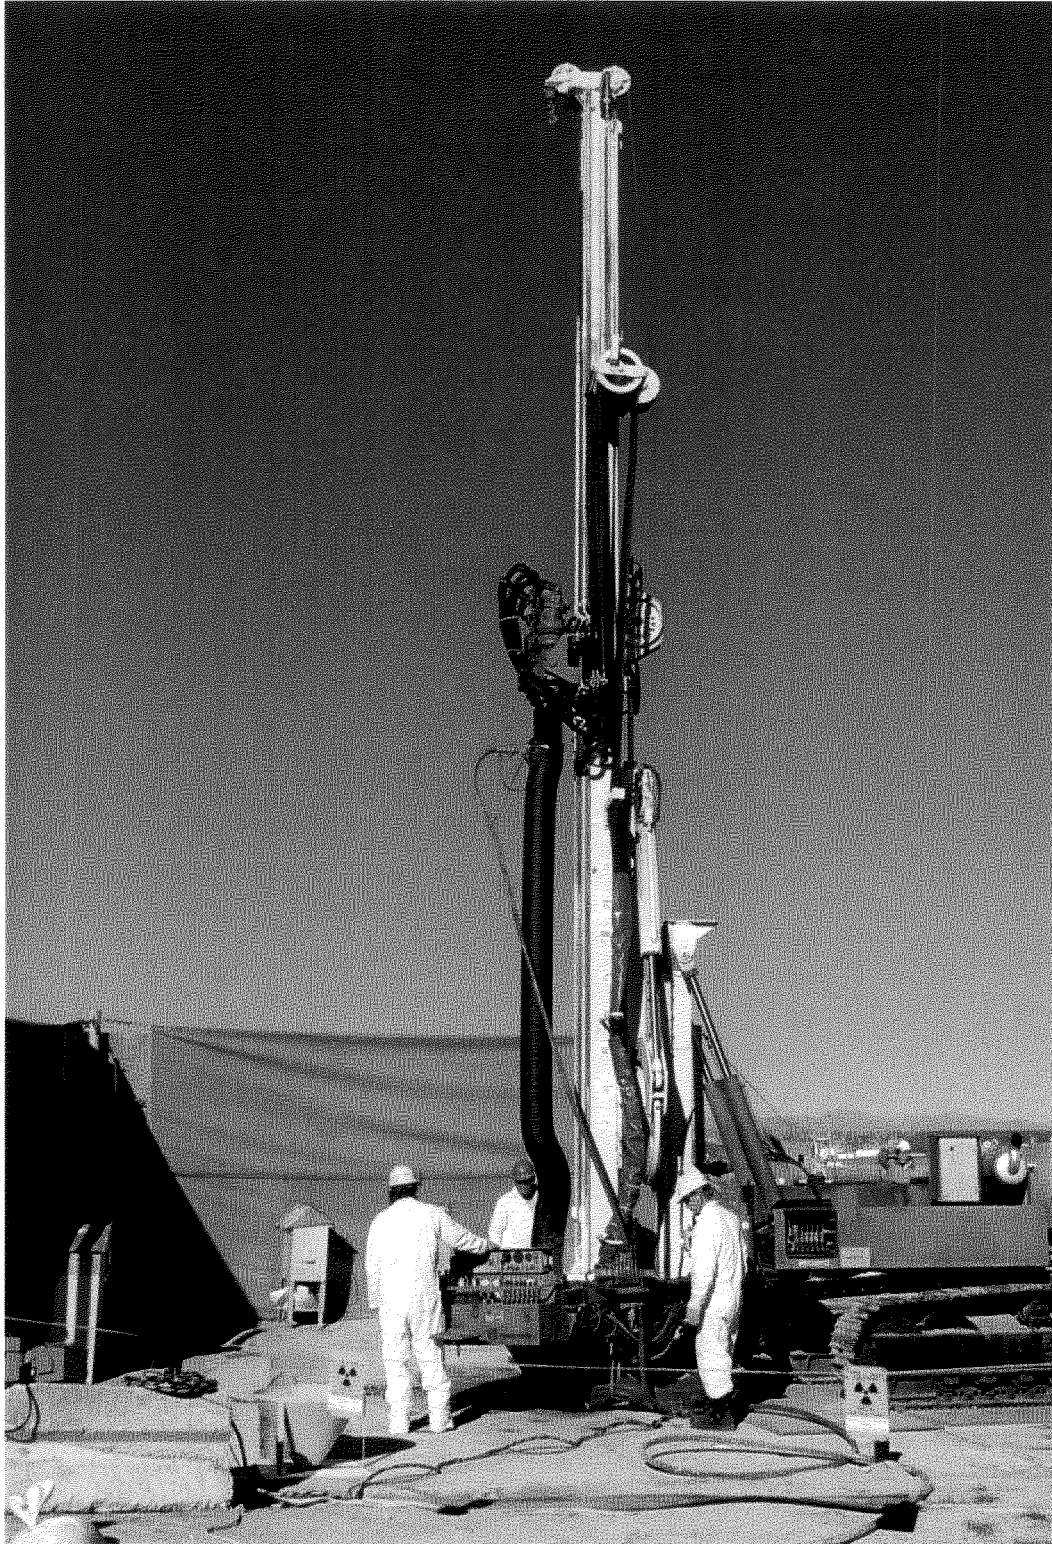
Figure B-2. In situ grouting remediation at the Idaho National Engineering and Environmental Laboratory Acid Pit.

Preconstructed thrust blocks were delivered to the study staging area, and placed over the area of the Acid Pit to be grouted. Edges were backfilled to lock blocks into place and contain grout returns. Grout was injected using a rotapercussion drill rig and a positive displacement pump for high-pressure injection, as shown in Figure B-2.

The drill was extended through the thrust block and drilled to the designated depth (i.e., to basalt or drill refusal). Grout was delivered through two 3-mm diameter nozzles, located approximately 180 degrees apart and vertically offset by approximately 2 in., and located nominally 6 in. from the bottom of the drill bit. Grout pressures used in the treatability study ranged from 3,500 to 6,000 psi. All grouting was performed at two revolutions per step, a step increment of 5 cm, and a step rate of 2 seconds per step (determined through the cold pit testing).

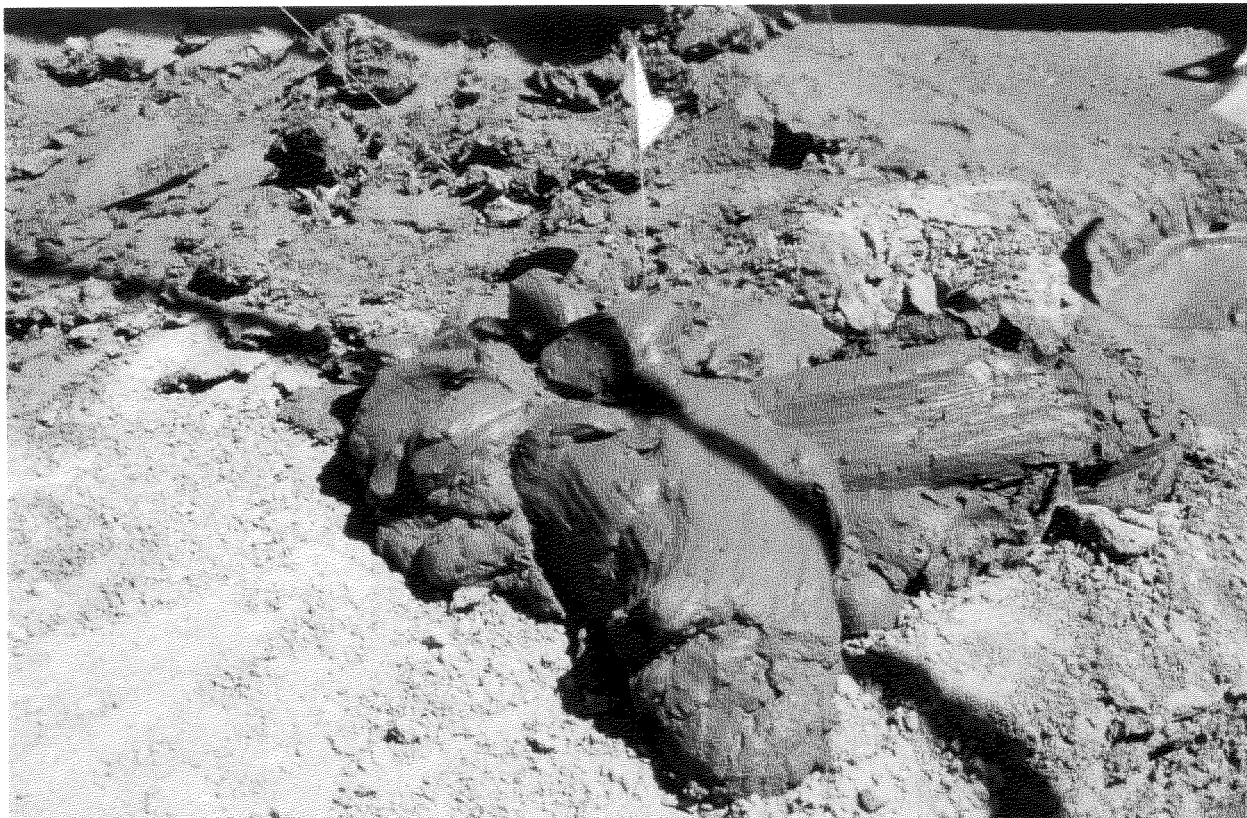
Figure B-3. Excessive grout returns caused by low soil porosity.

Grout returns, shown in Figure B-3, presented one of the major issues associated with using the jet grouting technique. The figure is representative of worst-case grout returns. Because of general lack of void space in soil being treated, grout returns increased and grout deliveries to each borehole decreased as grouting proceeded each day. Early in the day, grout returns were minor despite grouting the entire length of the 10 to 12-ft columns. However, as operations continued, some holes selected previously for grouting were abandoned because of excessive returns. Other potential solutions that were not instituted during this study include grouting in different patterns (e.g., every other hole) or grouting only those regions exhibiting detected contaminants.

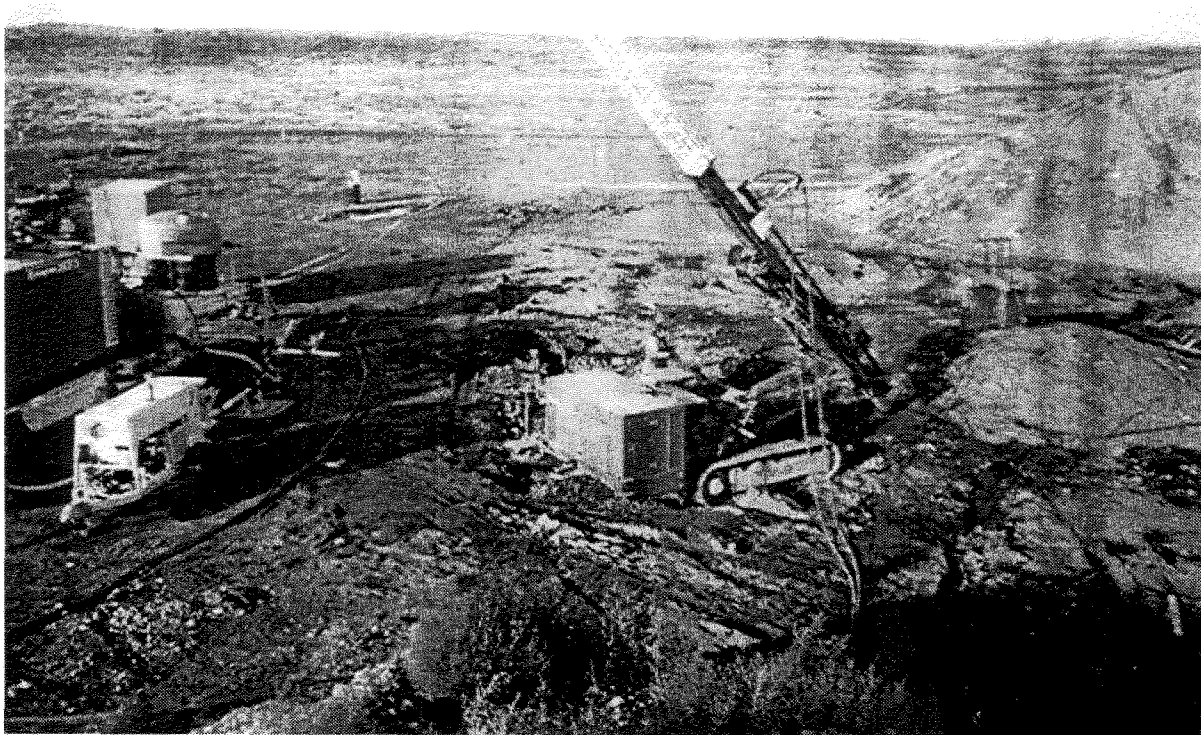
Figure B-4. Angle grouting at Brookhaven National Laboratory (Dwyer et al. 1999).

As shown in Figure B-4, installing angled walls involved drilling at a 45-degree angle, using the same parameters and techniques selected for the vertical walls. These angled walls met the vertical walls 5 ft below grade to form the trough. These techniques formed a barrier that extended 26 ft below grade and was 42 ft long, 30 ft wide, and approximately 3 ft thick. The contained area was 36 ft long, 24 ft wide, and 18 ft deep.

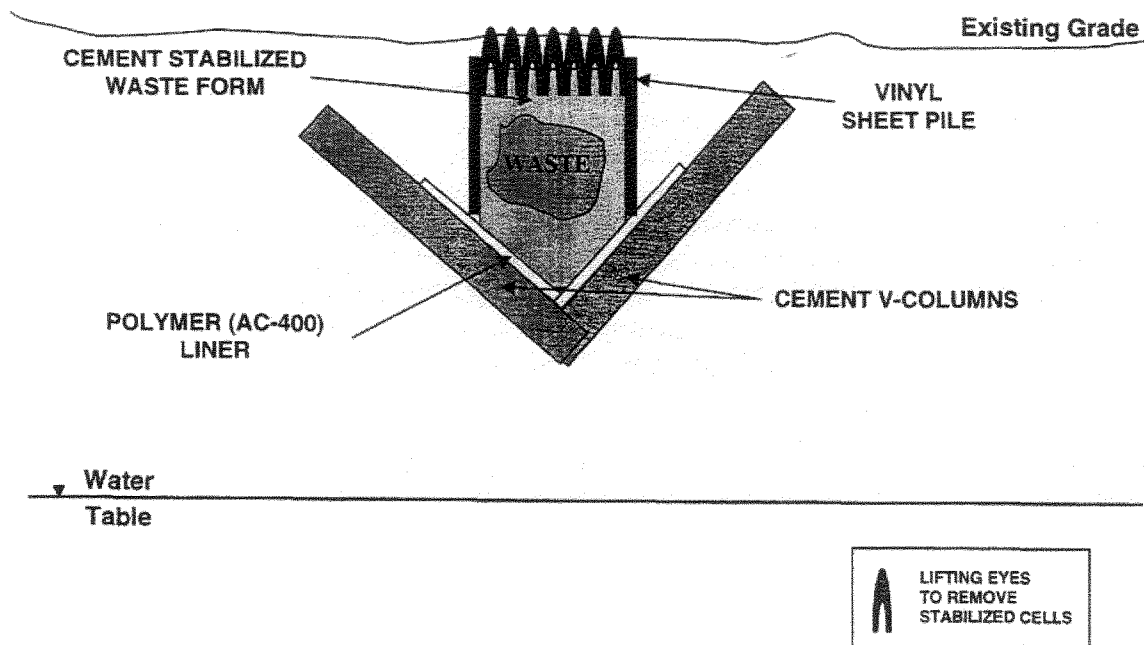
Figure B-5. Schematic of the close-coupled barrier combined with grout monolith at Brookhaven National Laboratory (Dwyer et al. 1999).

After verifying integrity of the close-coupled barrier using perfluorocarbon tracer, contents of the Glass Bottle Pit were jet grouted with a cement grout. Plastic sheet piling was placed around the waste pit, internal to the V-trough, to form a vertical rectangular wall around pit contents. Columns were placed on 21 in. centers until the entire interior of the sheet piling-delineated area was solidified. Spiral wound tubing was inserted vertically through the entire height of the grouted monolith so that the array of tubes outlined 4×4 -ft cells. U-shaped reinforcing rods also were set in the cells to serve as lifting attachments during eventual retrieval of the monolith. These features of the close-coupled barrier and waste-grout monolith are pictured in Figure B-5.

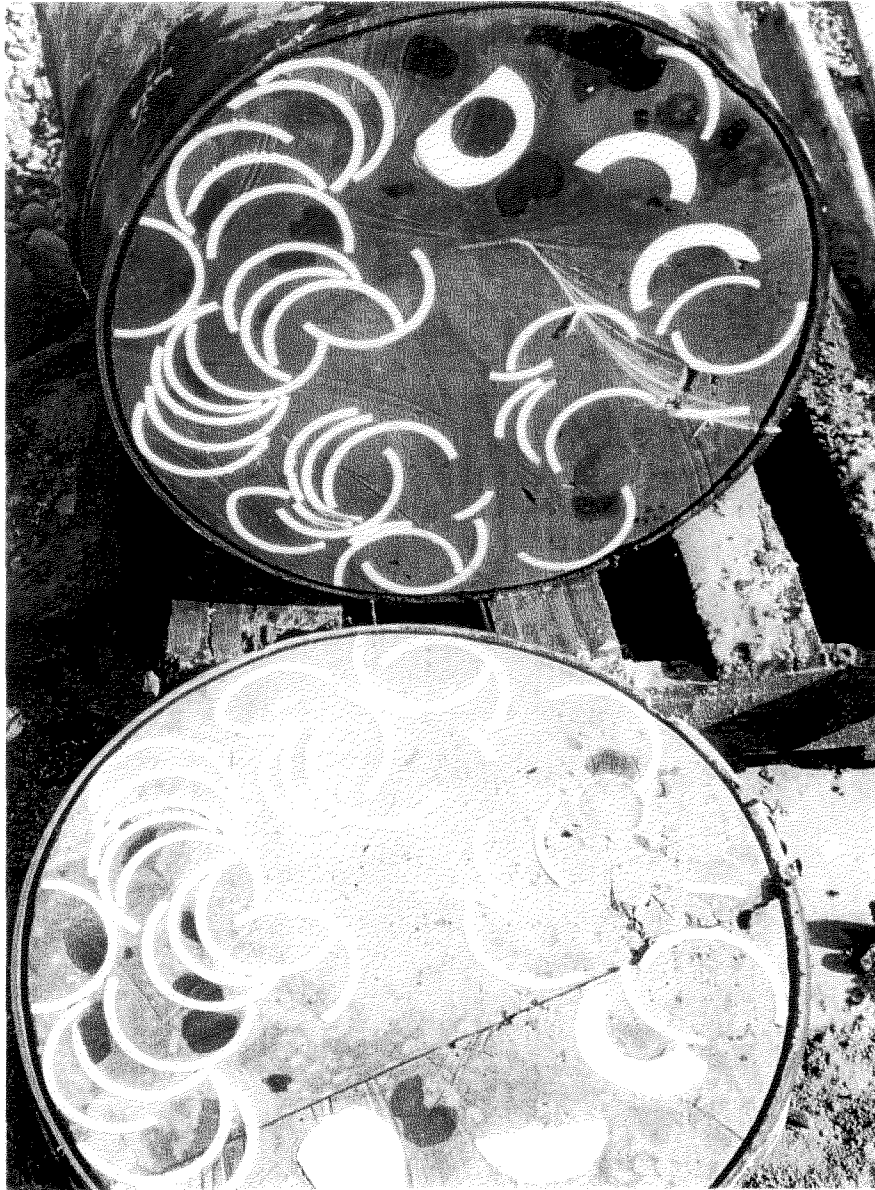
Figure B-6. Penetrated simulated waste containers with grouted contents.

Retrieval operations were performed in two phases: (1) an initial phase where soil overburden was removed as the monolith was fractured and removed and (2) a second phase during which the overburden was removed before retrieving the remaining monolith. In both phases, cement grout was found to have done an excellent job in encapsulating and solidifying the simulated waste. As shown in Figure B-6, examining the simulated waste pit verified that waste containers had been penetrated and their contents grouted.

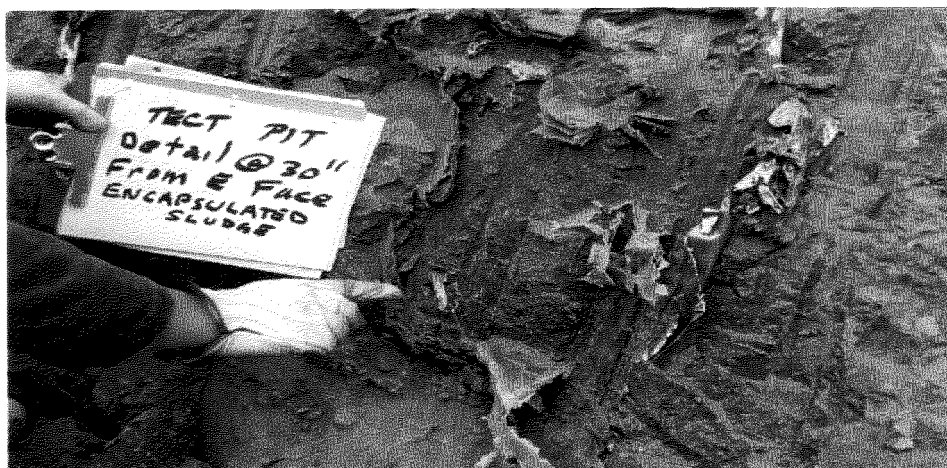
Figure B-7. Effective grouting results for simulated oil sludge at the Idaho National Engineering and Environmental Laboratory.

Both the TECT pit and paraffin pit demonstrated that the variety of waste types were mixed and encapsulated by the grout monolith. The steel drum bodies were penetrated and the contents mixed as the injection nozzles were withdrawn through the drum contents. Even problematic waste streams such as simulated Series 743 sludge drums (as shown in Figure B-7) were effectively encapsulated with grout.
